THE DEVELOPMENT OF AN ADVANCED ANTI-ICING/DEICING
CAPABILITY FOR U. S. ARMY HELICOPTERS. VOLUME II.
ICE PROTECTION SYSTEM APPLICATION TO THE UH-1H
HELICOPTER

J. B. Werner

Lockheed-California Company

Final Report for Period 30 June 1973 - 30 June 1975

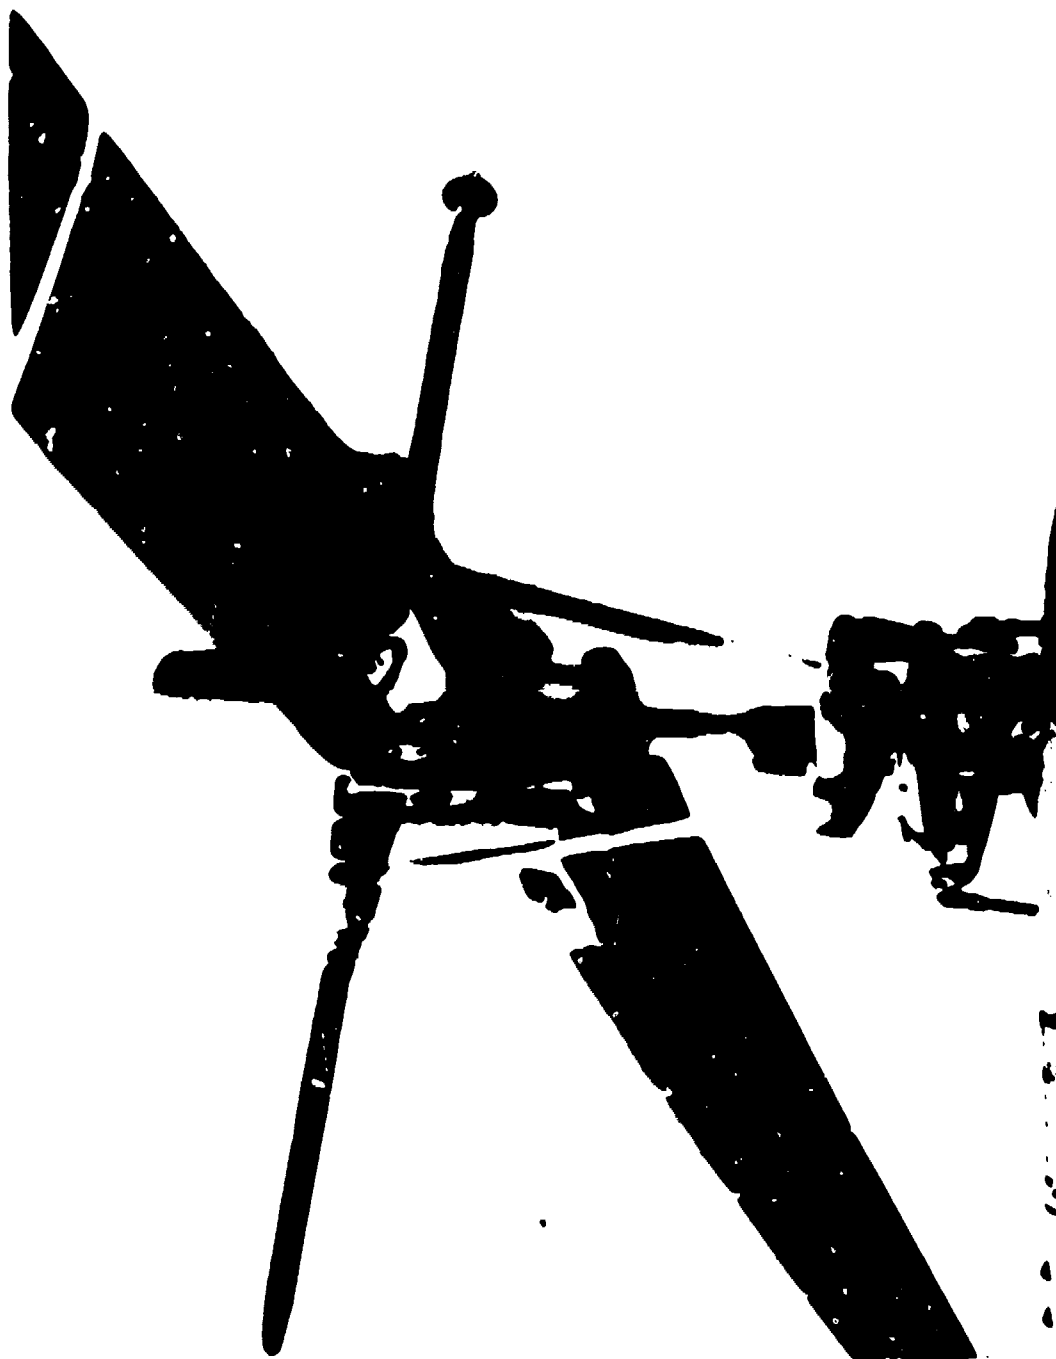
Figure 100. Typical Stabilizer and Rotor Head Condition at the Completion of an Icing Test Flight.
